TECHNICIAN TIMES

Volume 5 Issue 2

2002

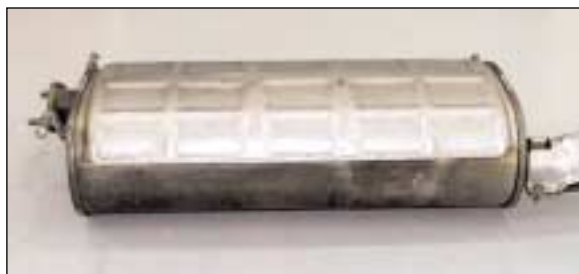
Old Style Silencer Assembly
P/N: 0K07A 40 100

From 10/5/01 production, the main body of the Sportage silencer (muffler) has been changed from rolled to stamped construction. There is no interchangeability between the new and previous parts.

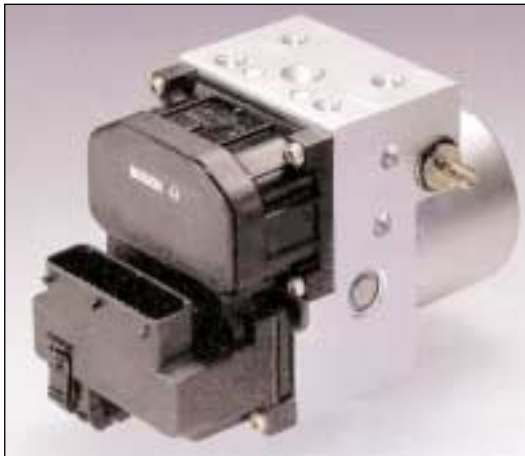
New ABS System For Optima

Starting with 12/12/01 production, the ABS system on (V6 equipped) Optimas is supplied by Bosch. The new system replaces the previous Teves Mk-20i version.

Although new for Optima, the system known as "Bosch 5.3" has been widely used throughout the industry. Bosch 5.3 ABS comes equipped with Electronic Brake force Distribution (EBD) and can be expanded in the future to include a Traction Control System (TCS). Self-diagnosis capabilities are built in, and fault codes will be retrievable using the Hi-Scan Pro. Watch for additional information in future Optima Service documentation. Should you encounter a problem in a Bosch 5.3 ABS equipped Optima before the updated documentation is published, contact Kia's Technical Assistance Hotline at 1-800-494-4542 for additional information.
